# Test Report

Report No	TR/12/562	
Client	UK Water Treatment Association Unit 27 Loughborough Technology Centre Epinal Way Loughborough Leicestershire LE11 3GE	
Authority & date	Project No. 2/36622 (SMO 7909483)	21 March 2012
Items tested	Corrosion Tests in Central Heating Systems filled with Hard and Base-Exchange Softened Hard Mains Water.	
Specification	Bespoke Corrosion Test Schedule	
Results	The above heating systems have been evaluated to the requirements of the above specification with the results detailed in this test report.	
Prepared by

*Name of Client:* UK Water Treatment Association  
*Product:* Corrosion Tests in Central Heating Systems filled with Hard and Base Exchange Softened Hard Mains Water.  
*Standard:* Bespoke Corrosion Test Schedule  
*Report Ref:* TR/12/562

**Results from Testing Corrosivity of Hard and  
Softened Water in Model Central Heating  
Systems at BSI, Loughborough**

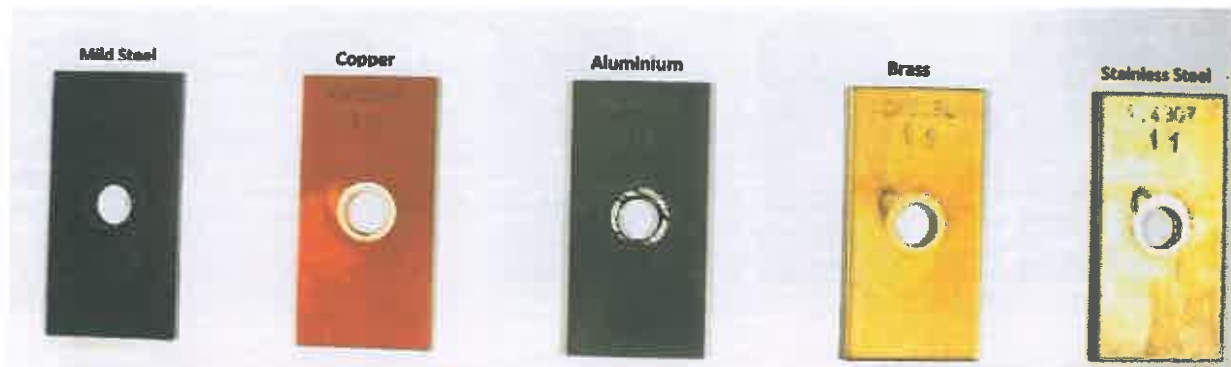
Fig 2 After 30 days

For the coupons exposed to artificially softened water (Figs 2-4), it was apparent from the appearance that there had been some general rusting of the mild steel coupons after 30 days exposure. The aluminium coupons had also blackened within 30 days. There may have been general corrosion of the copper and brass coupons but the discolouration, as on the stainless steel coupons, may have been due to deposition of other corrosion products. The appearance of the coupons removed after 3 months and 6 months had not changed appreciably from that of the coupons after 1 month exposure.

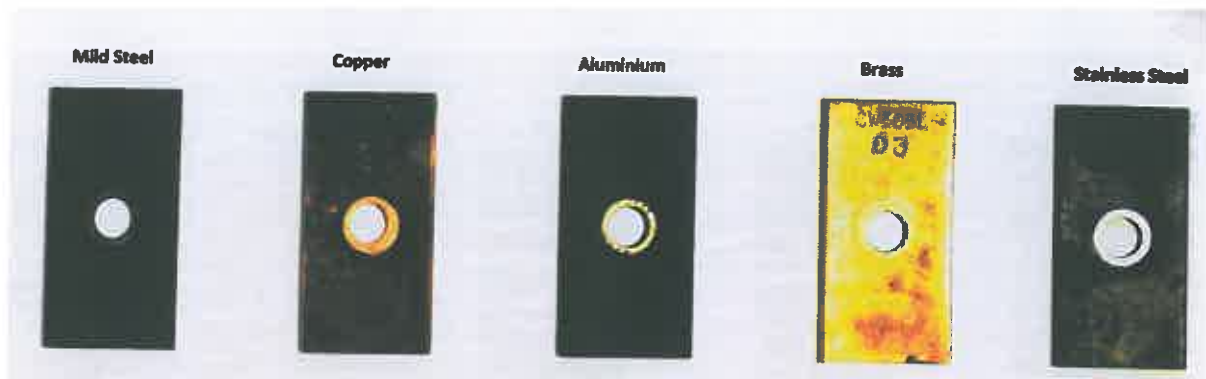
Fig 5 After 30 days

For the coupons exposed to hard water (Figs 5-7), all of the coupons appeared black or at least darkened on removal after 30 days. It was apparent that this was due to magnetite deposition due to corrosion of steel in the system. The coupons removed after 3 and 6 months also exhibited magnetite deposition, with increasing amounts of deposition with time.

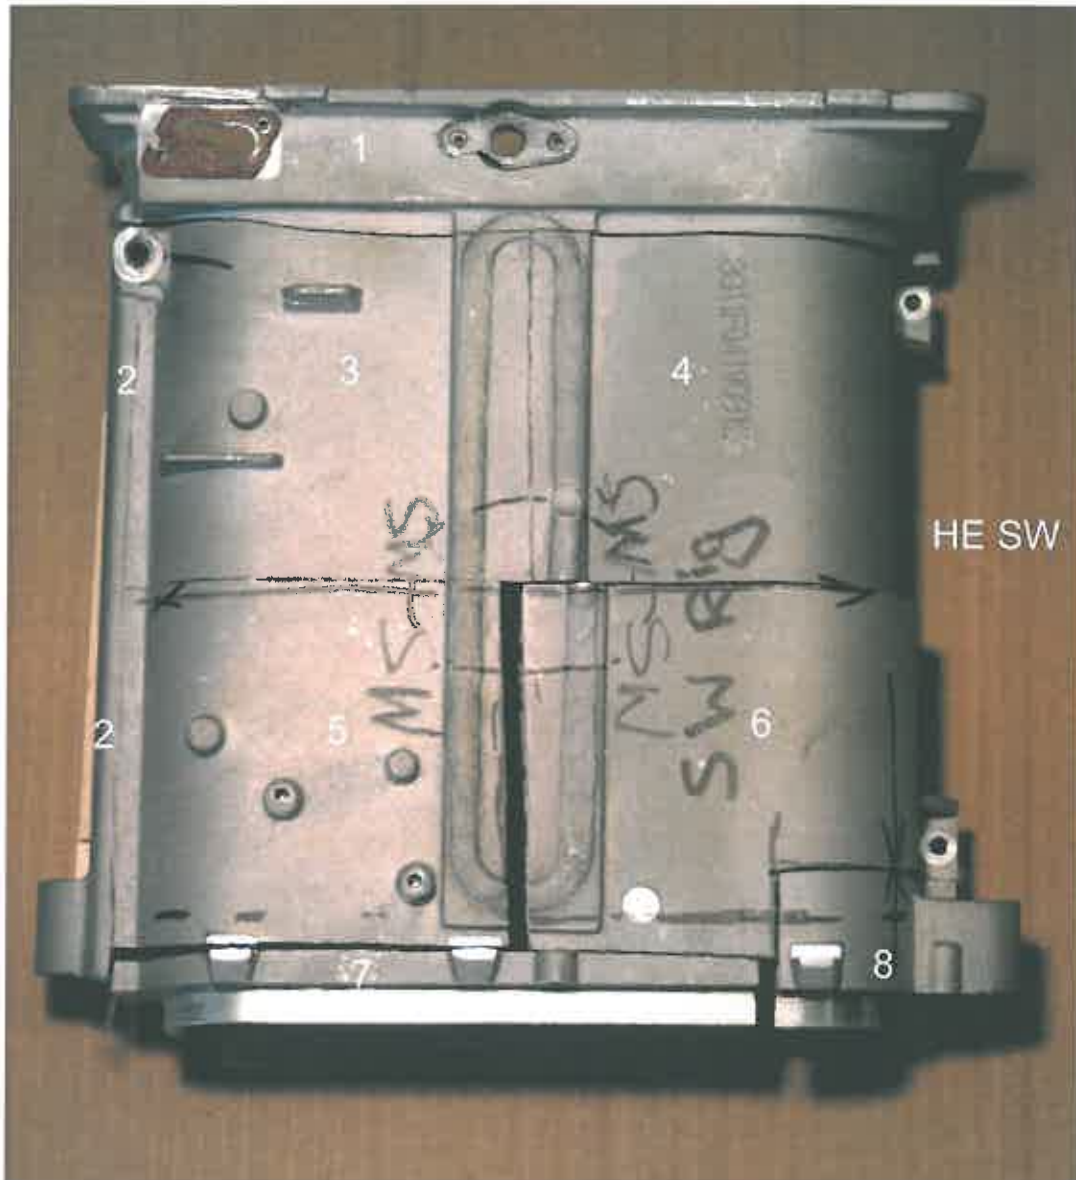
Fig 8 Whole Heat Exchanger from a Soft Water System with labelled sections

The heat exchanger from the base-exchange softened water rig is shown in figures 8 to 16. All the waterways inspected were covered with a thin layer of brown deposit, most likely iron oxide from some corrosion of the steel radiators. None of the water channels showed any signs of pitting or significant wall thinning. On part 7, on the upward facing waterway on the bottom of the heat exchanger, were 3 small mounds of alumina or aluminium hydroxide above small pit sites. A typical one is shown in Figs 15 and 16, before and after cleaning with phosphoric/chromic acid. The dimensions of the pits underneath the mounds were all <1mm across by 0.07mm deep. Hence, they were very shallow and only a tiny fraction of the wall thickness of 5mm.

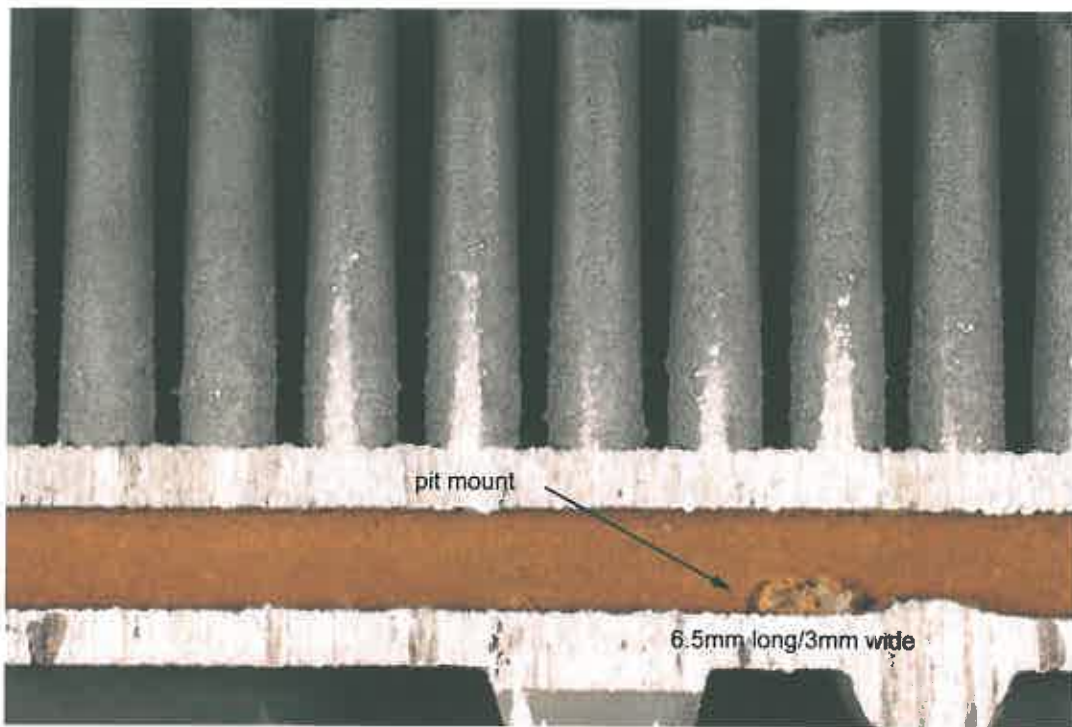
Fig 15 Waterway in pt 7, with pit mount

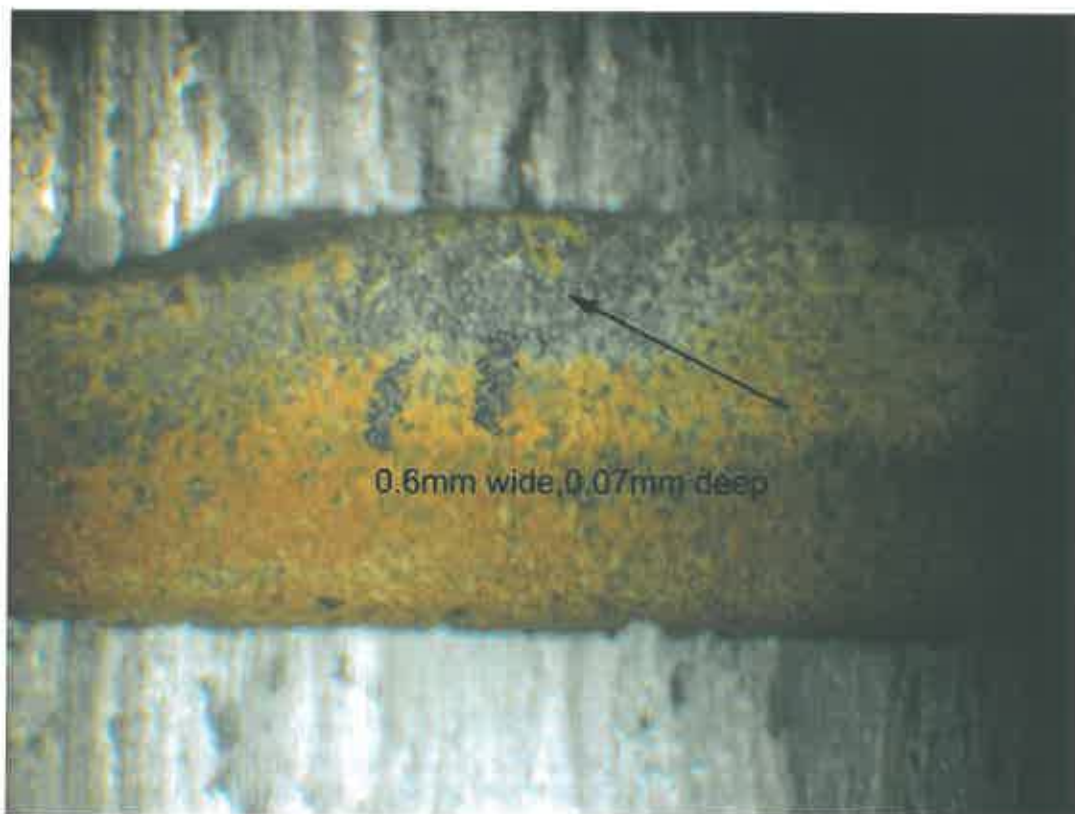
Fig 16 Pit after clean, pt7

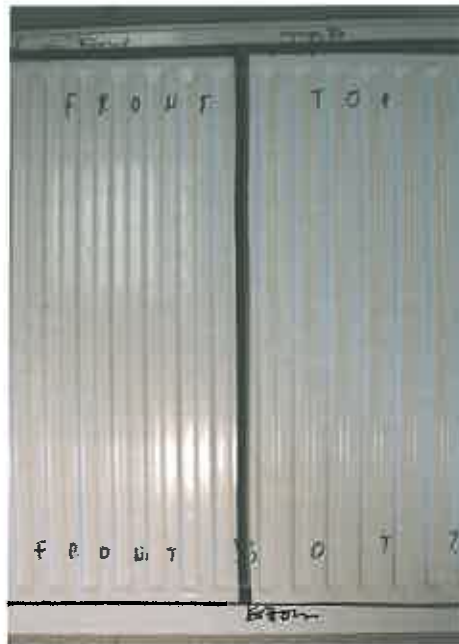
Fig 17 Soft Water Radiator cut marks

A radiator from each of the two rigs was sectioned with a band saw, as shown in figures 17 and 28 in Appendix 3, in order to inspect the top, bottom and vertical waterways. The appearance of the waterways from the base-exchange softened water rig are shown in figures 18 to 20 and from the hard water rig in figures 29 to 31. All of the waterways exhibited some slight general corrosion with light deposits of iron oxides but there was no significant thinning or pitting corrosion observed.

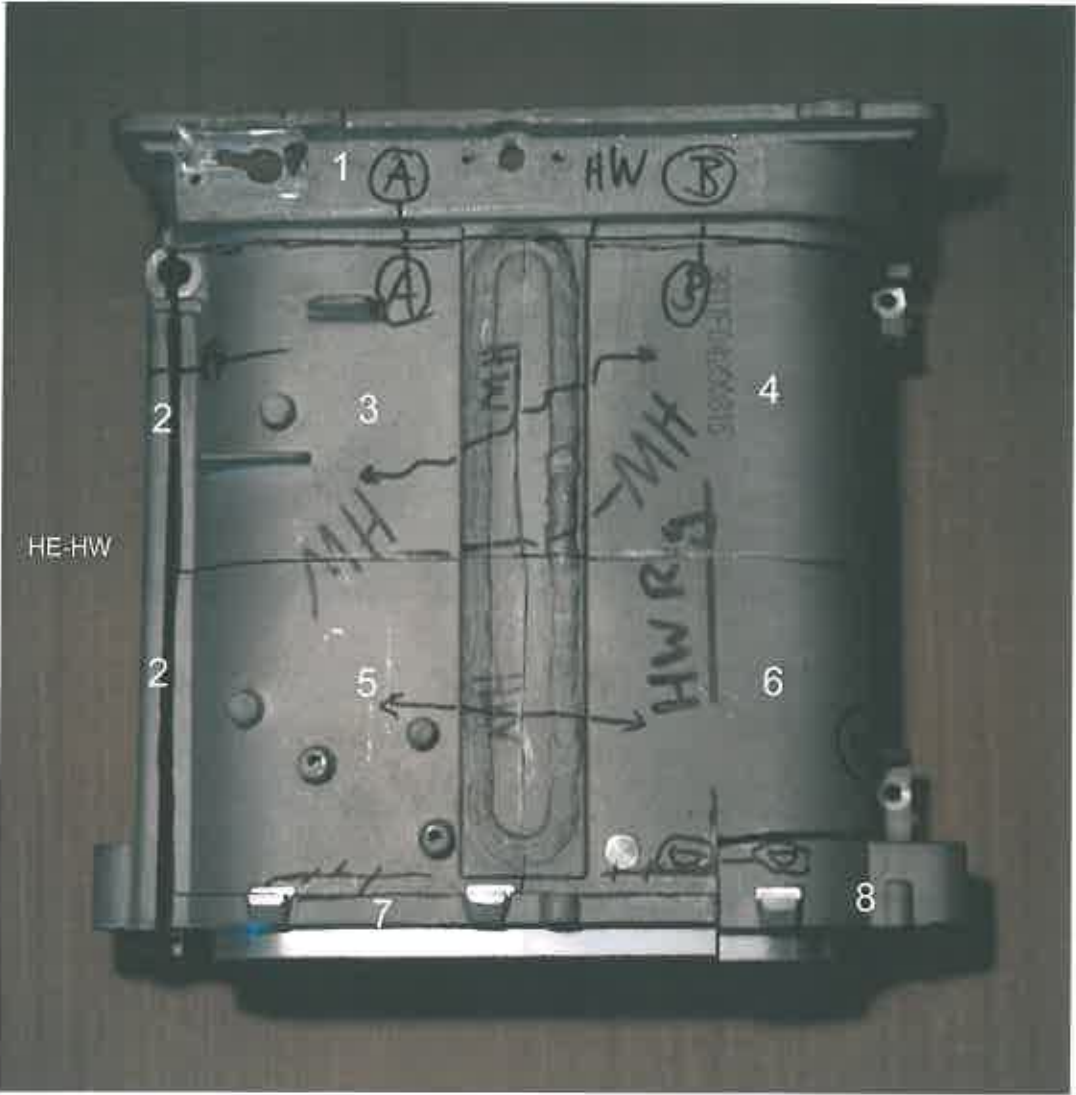
Fig 21 Whole Heat Exchanger from a Hard Water System

The heat exchanger from the hard water rig is shown in figures 21 to 27. Like the corrosion coupons removed from this rig, the waterways in the heat exchanger were all coated with a black magnetite layer. In some parts, the magnetite had spalled off in small areas revealing bright aluminium underneath, as shown for part 3 in figure 23. Again, no pitting was found in the internal waterways of this heat exchanger. A solitary pit was found in part 7 in the bottom waterway. On cleaning, this pit was found to be 0.5mm wide and 0.08mm deep. Hence, like the pits found in the heat exchanger from the softened water rig, this pit was of insignificant size.

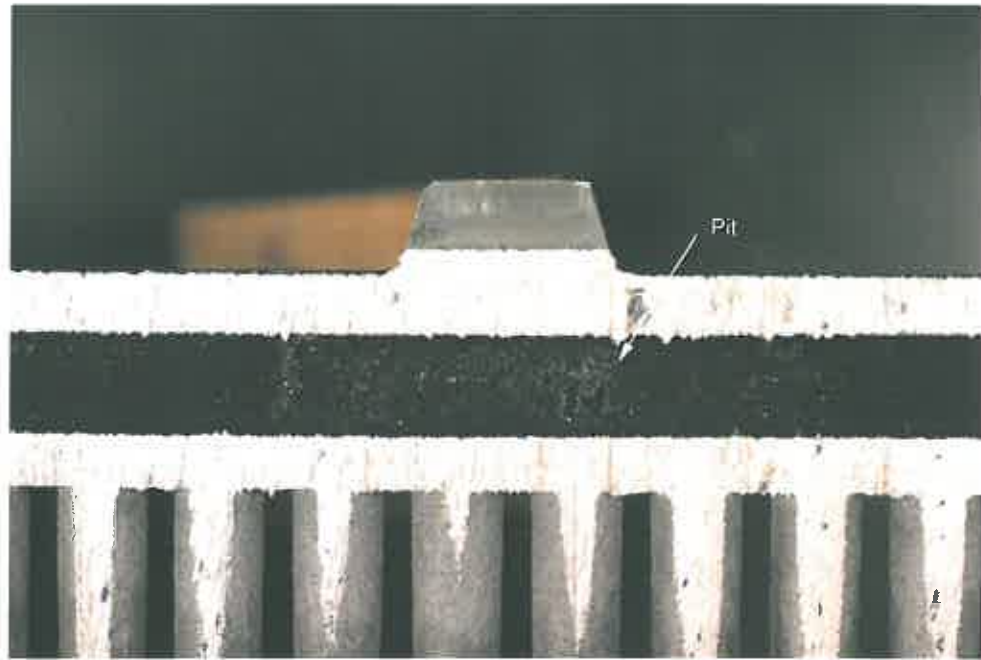
Fig 26 Waterway in pt 7 with location of pit mound

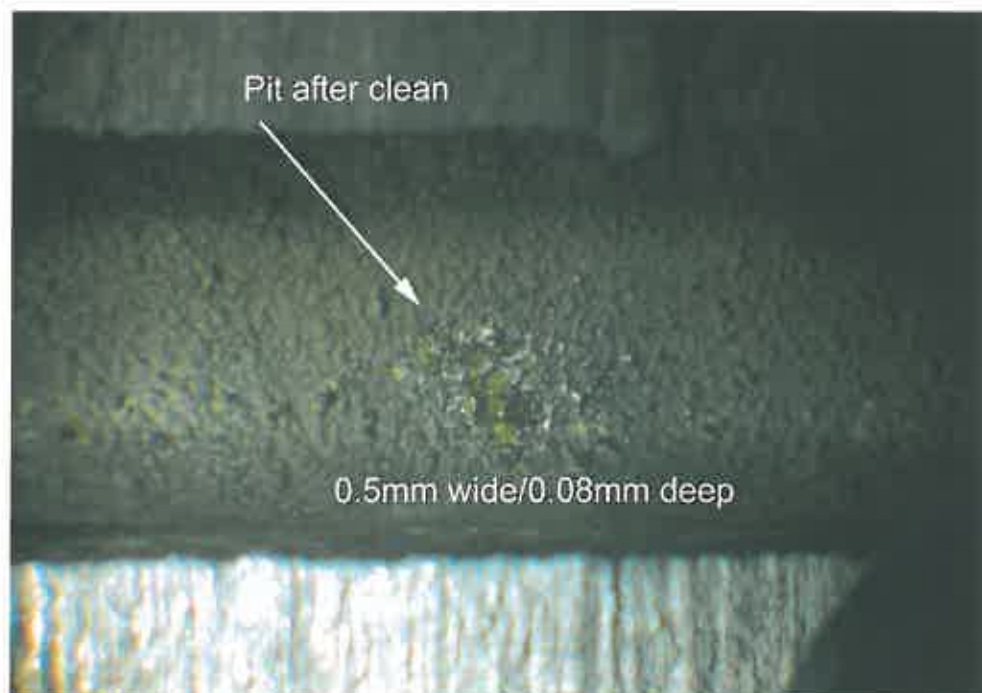
Fig 27 Pit in pt 7 after cleaning
