# Test Report

Report No	TR/12/562	
Client	UK Water Treatment Association Unit 27 Loughborough Technology Centre Epinal Way Loughborough Leicestershire LE11 3GE	
Authority & date	Project No. 2/36622 (SMO 7909483)	21 March 2012
Items tested	Corrosion Tests in Central Heating Systems filled with Hard and Base-Exchange Softened Hard Mains Water.	
Specification	Bespoke Corrosion Test Schedule	
Results	The above heating systems have been evaluated to the requirements of the above specification with the results detailed in this test report.	
Prepared by

*Name of Client:* UK Water Treatment Association  
*Product:* Corrosion Tests in Central Heating Systems filled with Hard and Base Exchange Softened Hard Mains Water.  
*Standard:* Bespoke Corrosion Test Schedule  
*Report Ref:* TR/12/562

**Results from Testing Corrosivity of Hard and  
Softened Water in Model Central Heating  
Systems at BSI, Loughborough**

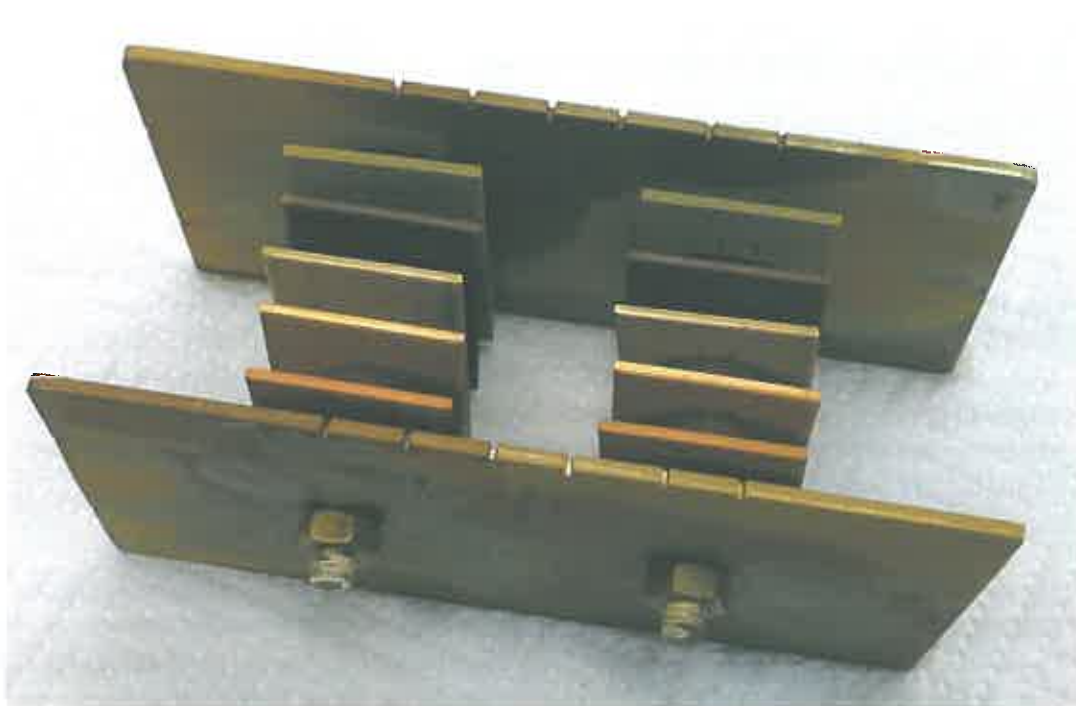
Figure 1 Coupon bundles after removal from rig.

At the start of the 6 month tests, the coupon bundles and holders were placed separately in 1 litre stainless steel vessels (3 for each rig). The vessels were then quickly filled with the recirculating test waters and the tests started. Fig 1 shows two coupon bundles attached to the stainless steel plates after removal from a stainless steel vessel at the end of a test period.

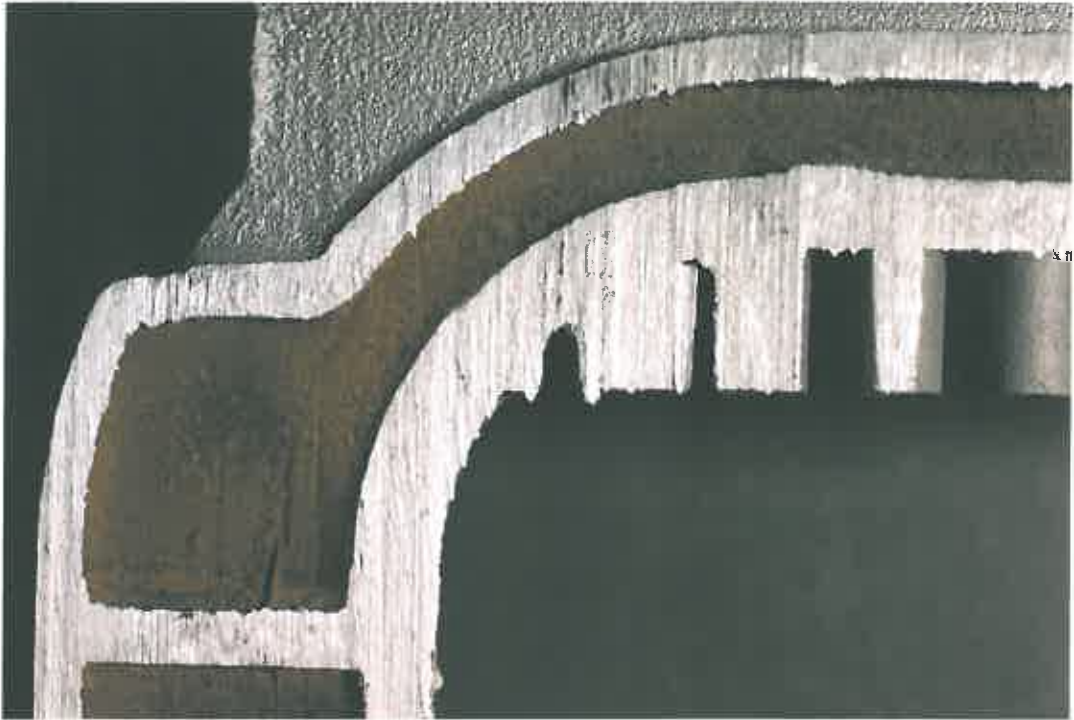
Fig 9: Waterway in pt 1

The heat exchanger from the base-exchange softened water rig is shown in figures 8 to 16. All the waterways inspected were covered with a thin layer of brown deposit, most likely iron oxide from some corrosion of the steel radiators. None of the water channels showed any signs of pitting or significant wall thinning. On part 7, on the upward facing waterway on the bottom of the heat exchanger, were 3 small mounds of alumina or aluminium hydroxide above small pit sites. A typical one is shown in Figs 15 and 16, before and after cleaning with phosphoric/chromic acid. The dimensions of the pits underneath the mounds were all <1mm across by 0.07mm deep. Hence, they were very shallow and only a tiny fraction of the wall thickness of 5mm.

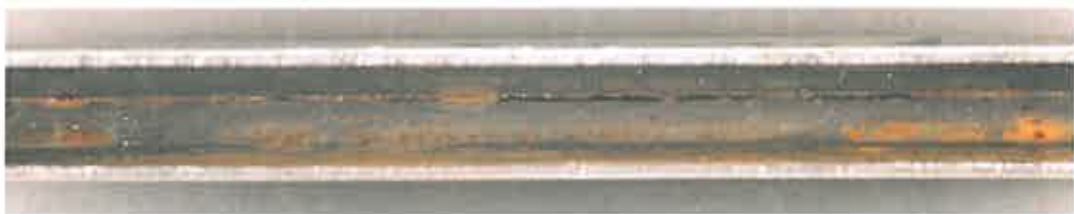
Fig 18 Radiator top waterway

A radiator from each of the two rigs was sectioned with a band saw, as shown in figures 17 and 28 in Appendix 3, in order to inspect the top, bottom and vertical waterways. The appearance of the waterways from the base-exchange softened water rig are shown in figures 18 to 20 and from the hard water rig in figures 29 to 31. All of the waterways exhibited some slight general corrosion with light deposits of iron oxides but there was no significant thinning or pitting corrosion observed.

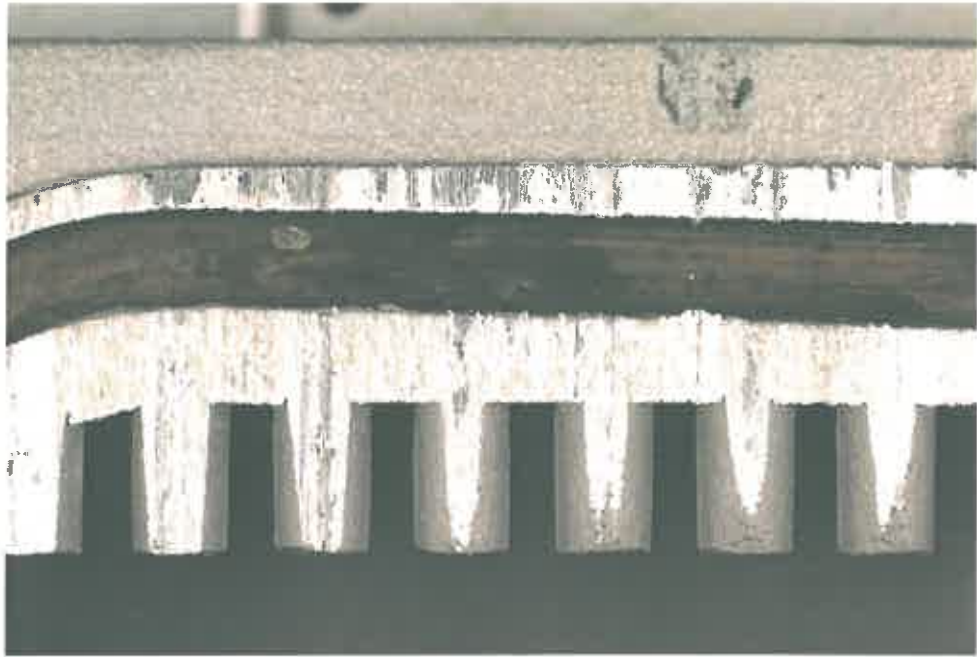
Fig 22 Water way in pt 1

The heat exchanger from the hard water rig is shown in figures 21 to 27. Like the corrosion coupons removed from this rig, the waterways in the heat exchanger were all coated with a black magnetite layer. In some parts, the magnetite had spalled off in small areas revealing bright aluminium underneath, as shown for part 3 in figure 23. Again, no pitting was found in the internal waterways of this heat exchanger. A solitary pit was found in part 7 in the bottom waterway. On cleaning, this pit was found to be 0.5mm wide and 0.08mm deep. Hence, like the pits found in the heat exchanger from the softened water rig, this pit was of insignificant size.
